EFSUMB Course Book, 2nd Edition

Ultrasound probe quality assurance by the clinical user

Bálint Botz¹

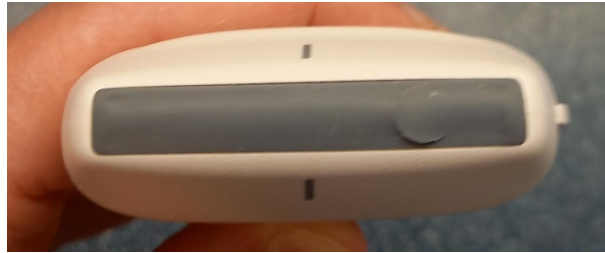
Figure 1 A full thickness tear of the probe lens means that gel can penetrate even down to the piezoelectric elements of the transducer. Also, this probe cannot be properly cleaned between examinations. Thus, it had to be disconnected

immediately. Subsequent re-lensing of the probe was successful, at a fraction of the cost of the new probe.

Significant physical damage may even warrant immediate removal of the probe without further testing (Figure 1). The lack of visually apparent damage however does not rule out the presence of probe faults per se. Even if external damage such as cracks do not influence the image quality at the moment, they can pose a serious infection control issue, by making proper cleaning of the probe impossible (1). Furthermore, if they remain unattended external damages can progress, and ultrasound gel leaking into the internal elements of the probe can induce further deterioration. Thus, early intervention and repair of probes with visible damage is of key importance.

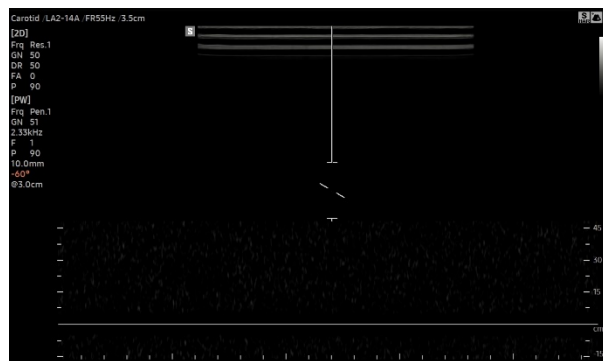
Figure 13 Signal is considerably reduced as the gain is decreased.

Noise testing can be done with pulsed wave (PW) Doppler, with the sampling gate positioned in the center of the image, and also for colour Doppler (colour box positioned in the center of the deeper part of the image). Again record the gain levels at which noise disappears from the image (4). Excessive noise present at even low gain levels warrants further equipment testing by professionals (Figures 9-14).

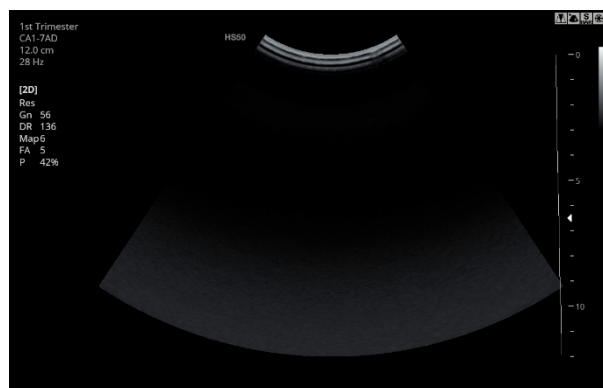
Figure 18 Subtle, focal inhomogeneity of the reverberation lines on the left, but no defect (10).

Delamination is a typically more subtle, and also more common form of probe defects. In this cases the reverberation lines are focally disrupted, but not entirely absent (Figures 18-20).

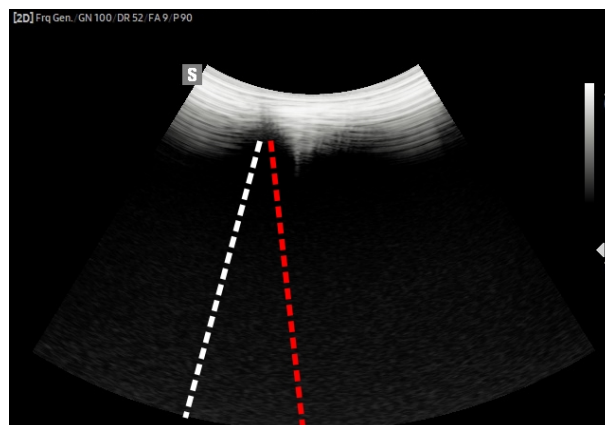
Figure 29 In the affected area the orientation of the artifact shows angular deviation from the expected 90 degrees, indicating image distortion. The expected normal direction is indicated by the white dashed line (Courtesy of Dr. Ákos Járny).

Focal inhomogeneities and subtle weakening of the reverberation artifacts may indicate piezo-element weakness or malfunction. Changes in its orientation highlight image distortion (Figures 28-29)

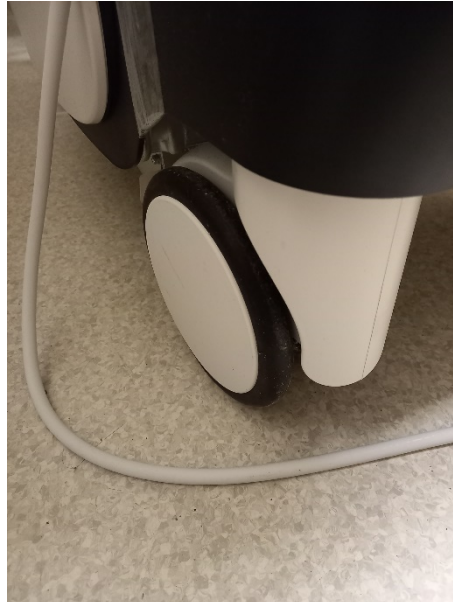
Figure 32 A substantial number of equipment damages can be prevented by a safe practice. A cable trailing on the ground is one of the most common and easily avoidable source of probe damage.
